ON-SITE GMAX TESTING EVALUATION

Site Name and Address: James A. Dillon Park

Test Dates	5-18-17 and 6-8-17
Report Date	6-13-17
Sport Field Type	Football
Weather Conditions	Sunny
Air Temperature	Recorded air temp at 10am – 63 Degrees
Test Method	ASTM F1936 and according to device instructions
Test Device	Clegg Impact

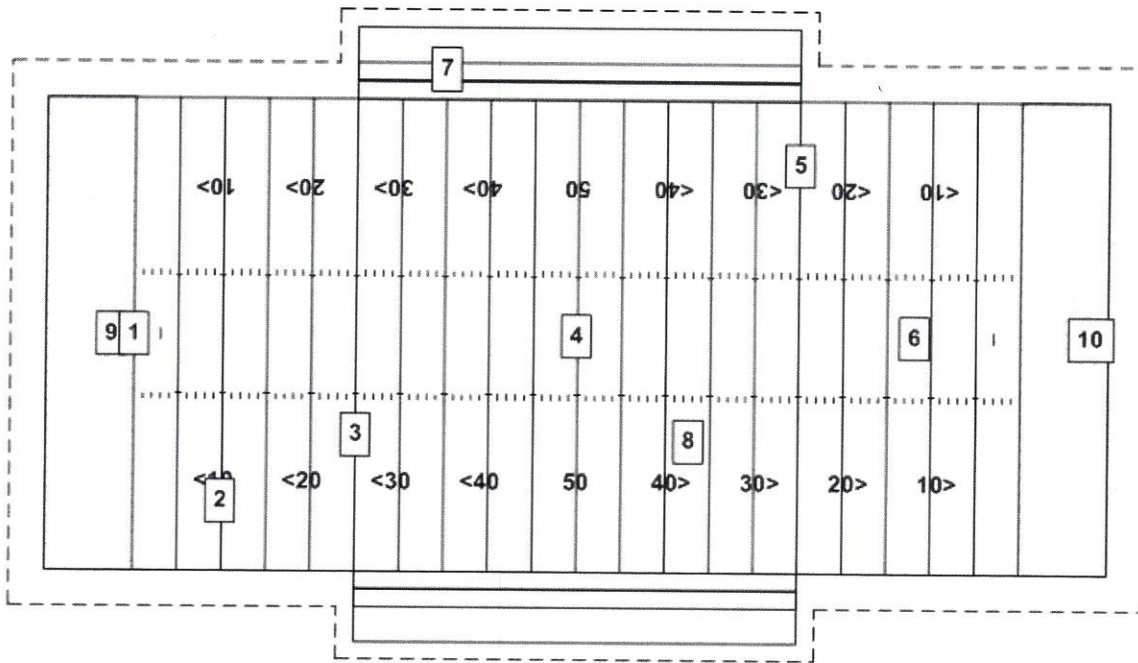
TEST POINT MAP:

In accordance with ASTM standards, there are 10 test points for a football field. There are 3 drops at each test point. To avoid compacting the same exact area over and over again with the hammer, the 3 drops are done within a 30-inch radius of the test location.

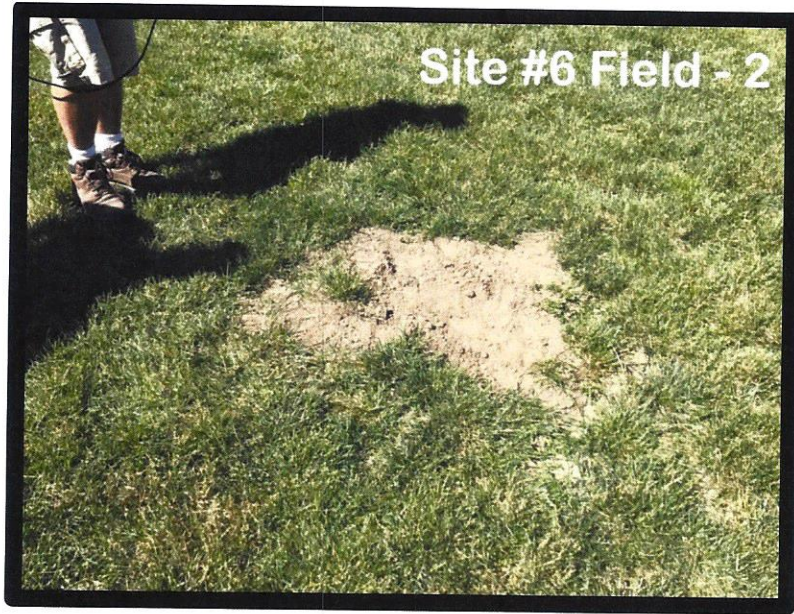
Average overall gmax for field # 2 was 90. Site 10 is high due to location which is right next to goal post. Site #6 picture below is a potential safety hazard.
